### **Phase I Environmental Site Assessment and Phase II Limited Subsurface**

Project No. 034-18192

RE: Phase I Environmental Site Assessment  
Proposed Acquisition Property  
17965 Monterey Road  
APN 764-12-006  
Morgan Hill, California 95037

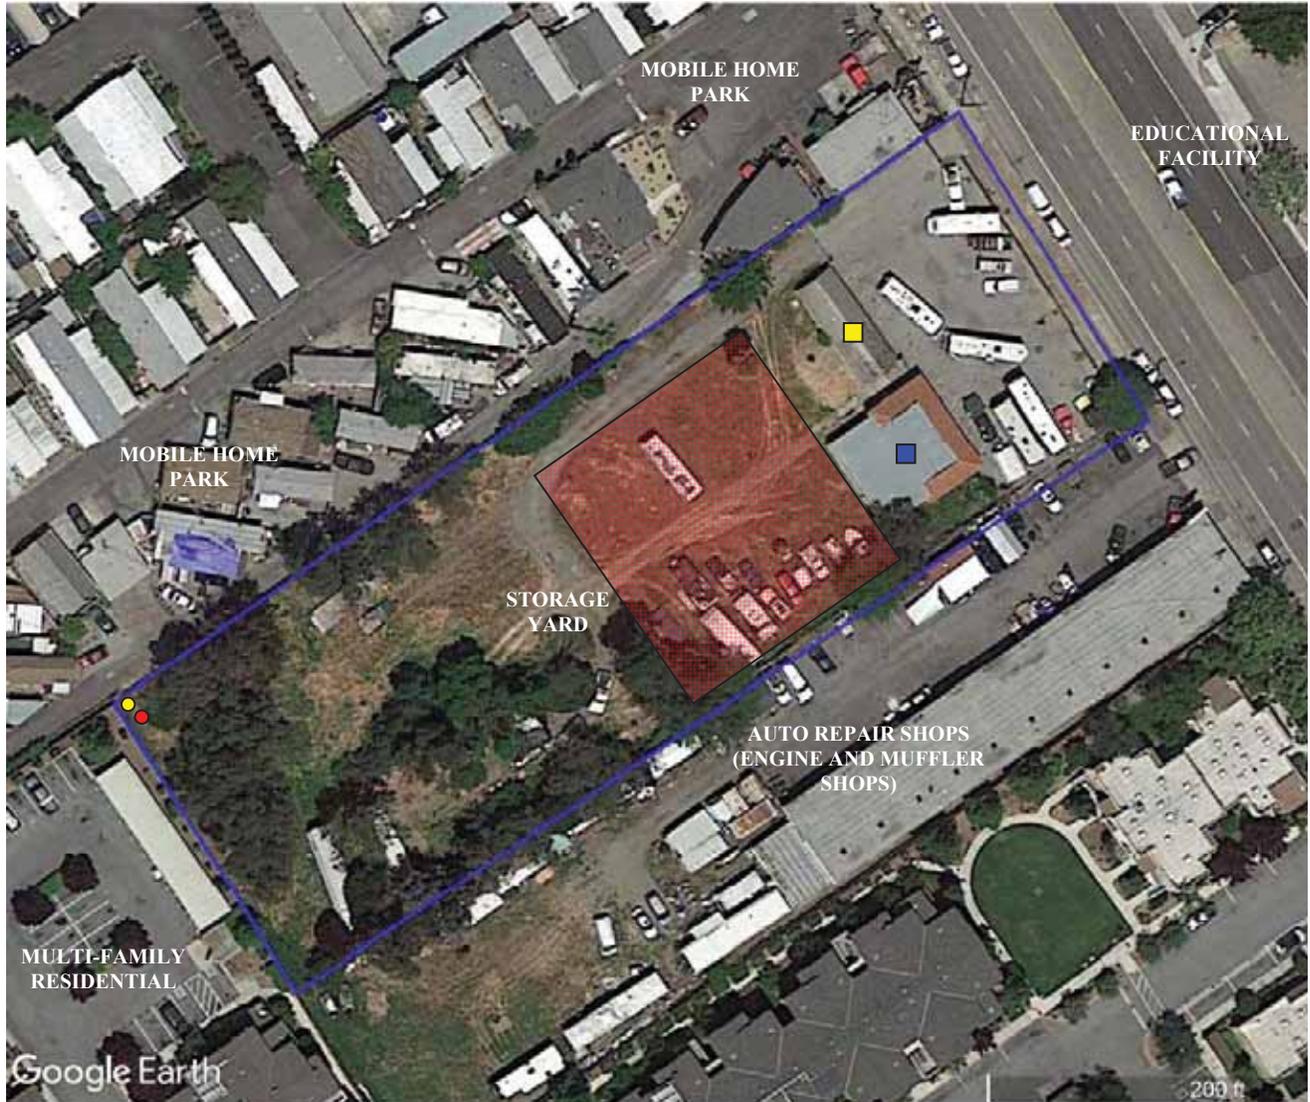
- = STORAGE BUILDING
- = FORMER GREENHOUSE BUILDING
- = SOIL MOUND
- = MOUND OF ASPHALTIC MATERIAL
- = APPROXIMATE AREA UTILIZED FOR PLANT STORAGE BY FORMER NURSERY OCCUPANT (BASED ON 1982 AERIAL PHOTOGRAPH)

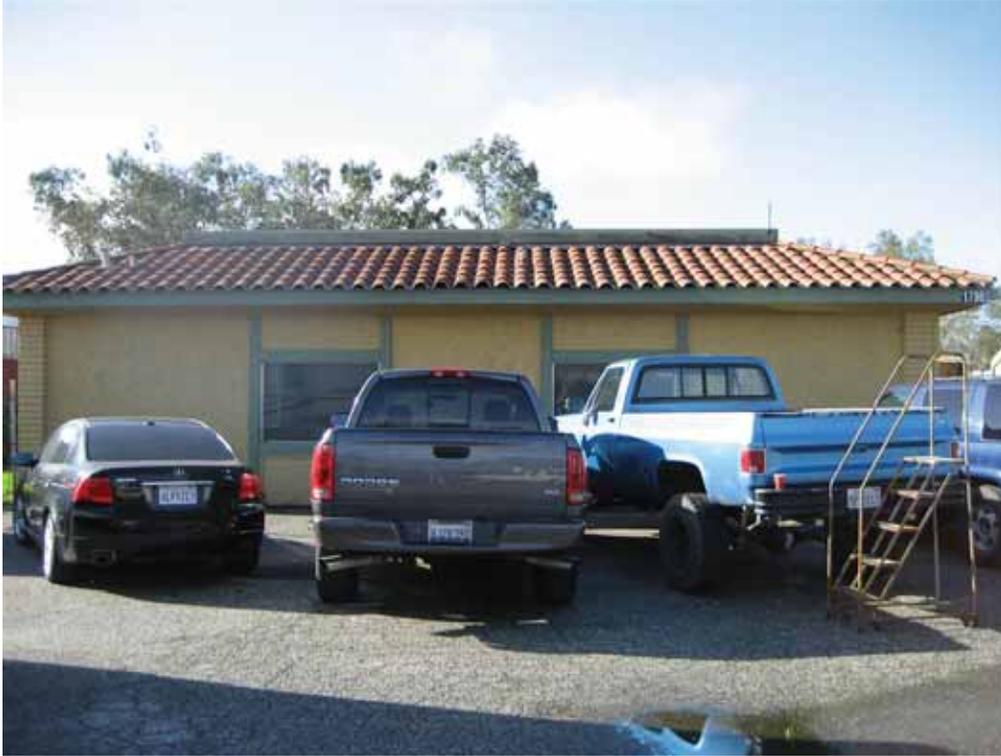
- The subject site was observed to be occupied by two commercial buildings, a paved parking area, an unpaved storage yard, and landscaped areas (See Photographs No. 1 - No. 10). The on-site commercial buildings were observed to be associated with a subject site address of 17965 Monterey Road. The southern-most structure, with a structural footprint of approximately 2,200 square feet, was observed to be of wood frame construction on a slab-on-grade foundation. The northern-most structure, with a structural footprint of approximately 1,000 square feet, was

**Photo 1:** View of the commercial building located in the southeastern portion of the subject site currently utilized for storage.

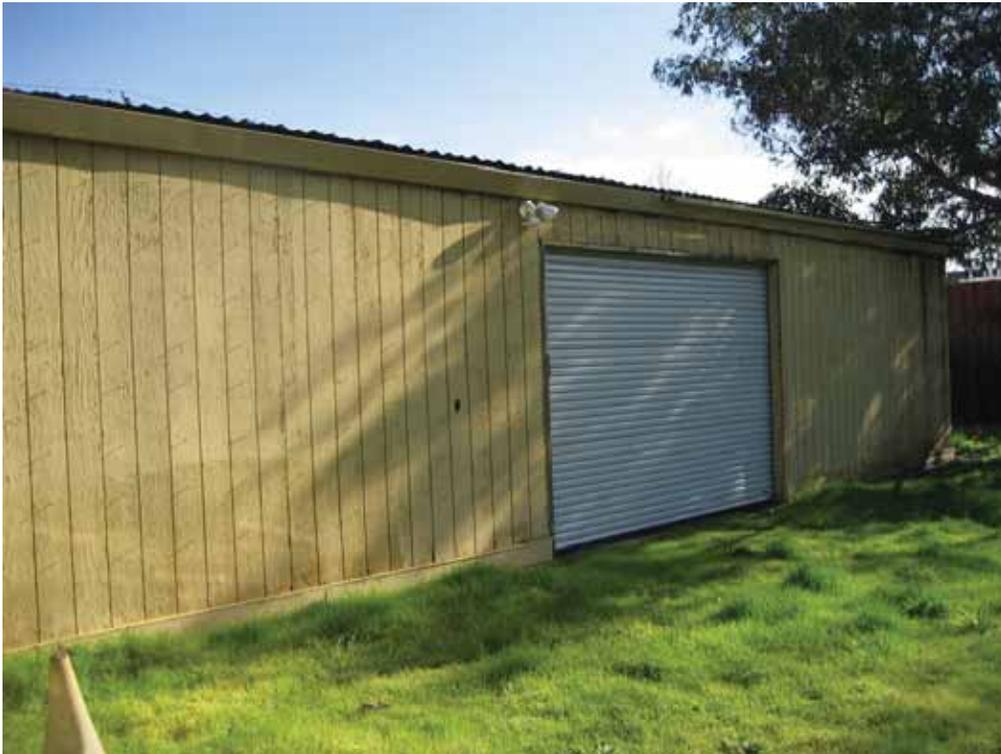
**Photo 2:** View of the rear (western face) of the commercial building located in the southeastern portion of the subject site currently utilized for storage.

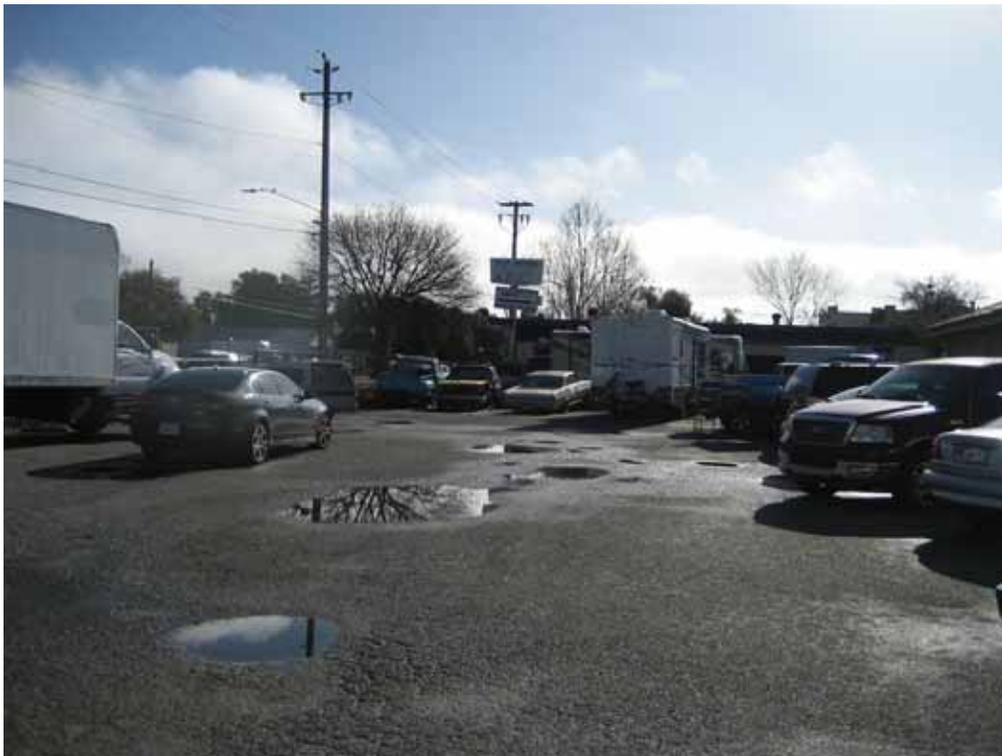
**Photo 4:** View of the paved parking lot located in the eastern portion of the subject site.

- Numerous vehicles, including sedans, pickup trucks, trailers, a tractor trailer, recreational vehicles (RVs) and boats were observed in the paved parking area located in the eastern portion of the subject site and within an apparent storage yard located in the central and western portions of the subject site (See Photographs 4, 7, 8, 14, 15 and 16). Mr. Scoffone stated that he owned many of these vehicles and that space was being rented to others for storage of the remaining vehicles. Mr. Scoffone stated that the vehicles he owned are functional; however, some of the other vehicles observed on site did not appear to be functional. No odors, surface staining, stressed vegetation, or other obvious evidence of a release of fuel or engine fluids was observed in association with the vehicles located on site. However within the scope of this Phase I ESA, it was not possible to inspect the ground beneath all of the vehicles located on site and it is thus possible that some engine fluid leakage will be revealed upon removal of the vehicles.

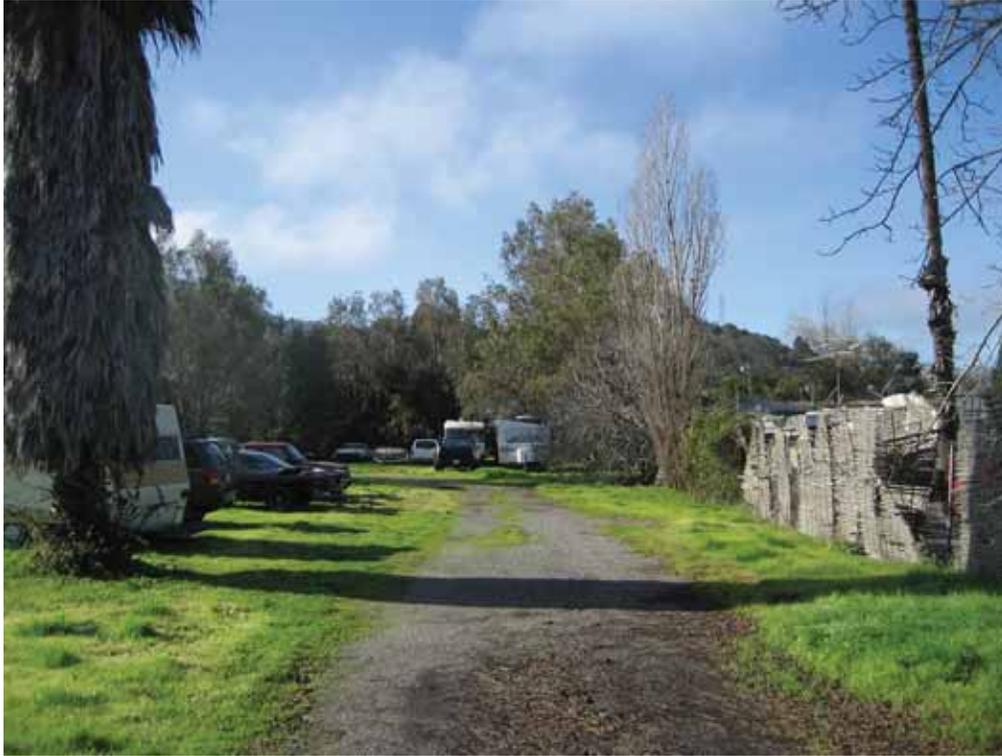
**Photo 5:** View of the central-northern portion of the subject site.

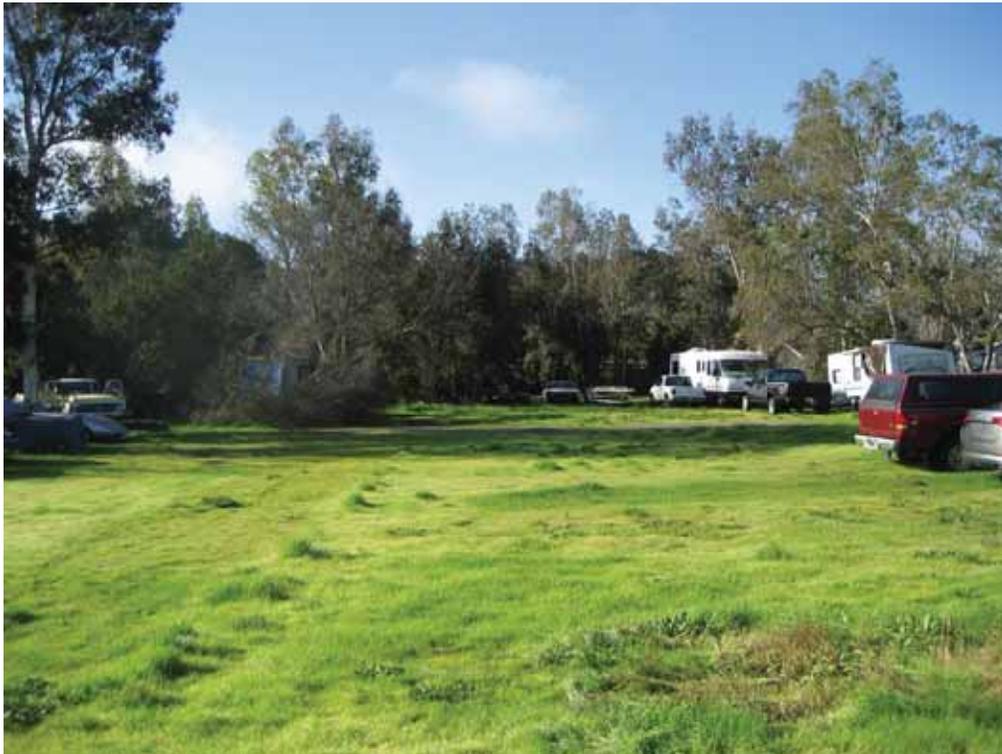
**Photo 6:** View of the central portion of the subject site.

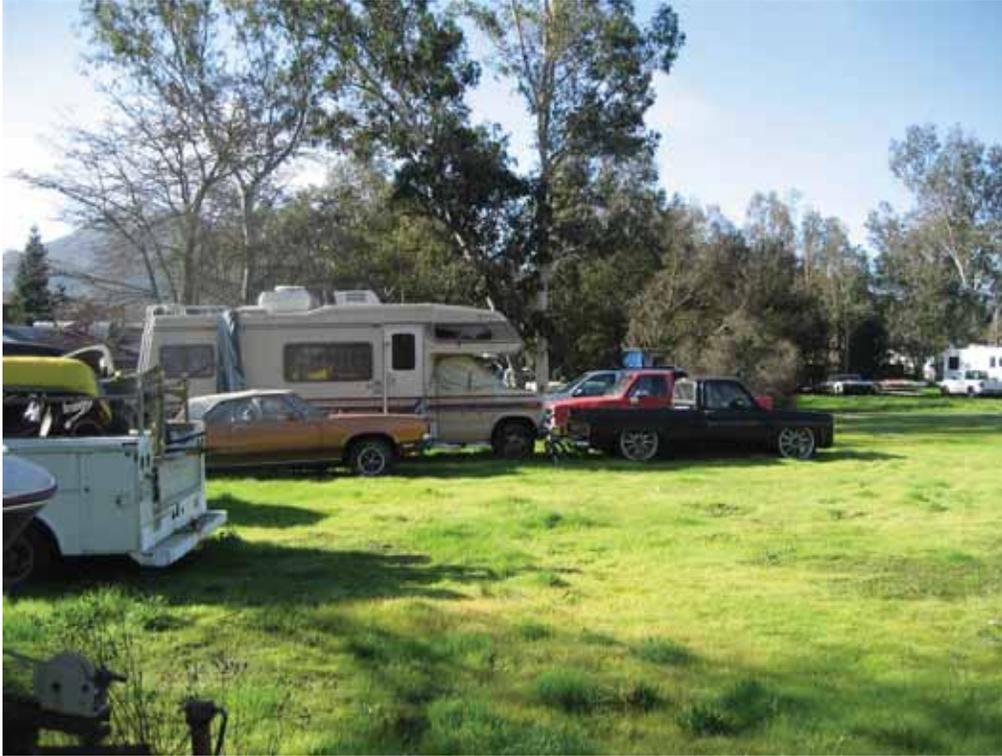
**Photo 7:** View of the central-southern portion of the subject site.

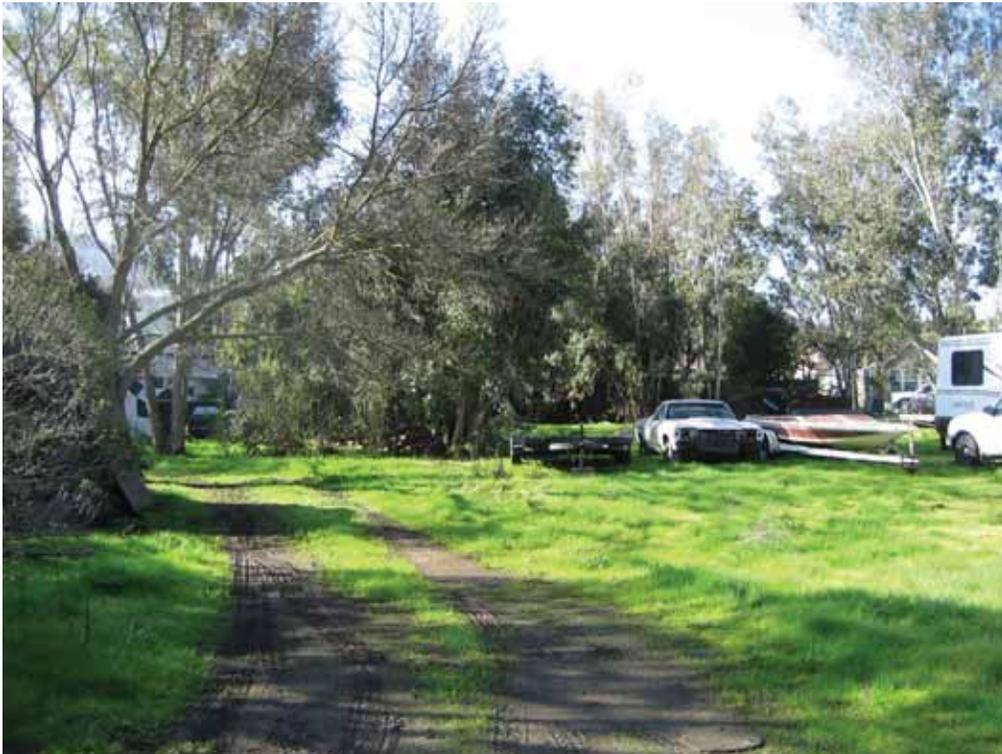
**Photo 8:** View of the northwestern portion of the subject site.

- During Krazan's January 10, 2019 site reconnaissance, a relatively large soil mound was observed in the northwestern corner of the subject site. No odors, surface staining, stressed vegetation, or other obvious evidence of the presence of hazardous materials or hazardous waste were noted in association with the soil mound. Mr. David Scoffone, the owner of the subject site familiar with the subject site for the past 15 years, stated that he believed the soil mound to have been derived from the construction of an on-site depression utilized for stormwater control. Mr. Scoffone stated that he believed the referenced depression to have been constructed by a former plant nursery occupant of the subject site. However, the plant nursery appears to have terminated its occupation of the subject site by 1999, indicating that it is unlikely that Mr. Scoffone has first-hand knowledge of the origin of the on-site soil mound as he indicated that he has been familiar with the subject site since 2003. Furthermore, no information concerning the origin of this soil mound was obtained from other sources during the course of this assessment. Krazan's experience indicates that imported soil can be contaminated with agricultural chemicals or other hazardous materials, dependent upon the specific location from which the soil is derived. Consequently, the origin and composition of the soil contained within this mound related to potential contaminants is unknown relative to future use in the proposed redevelopment of the property or for disposal purposes.

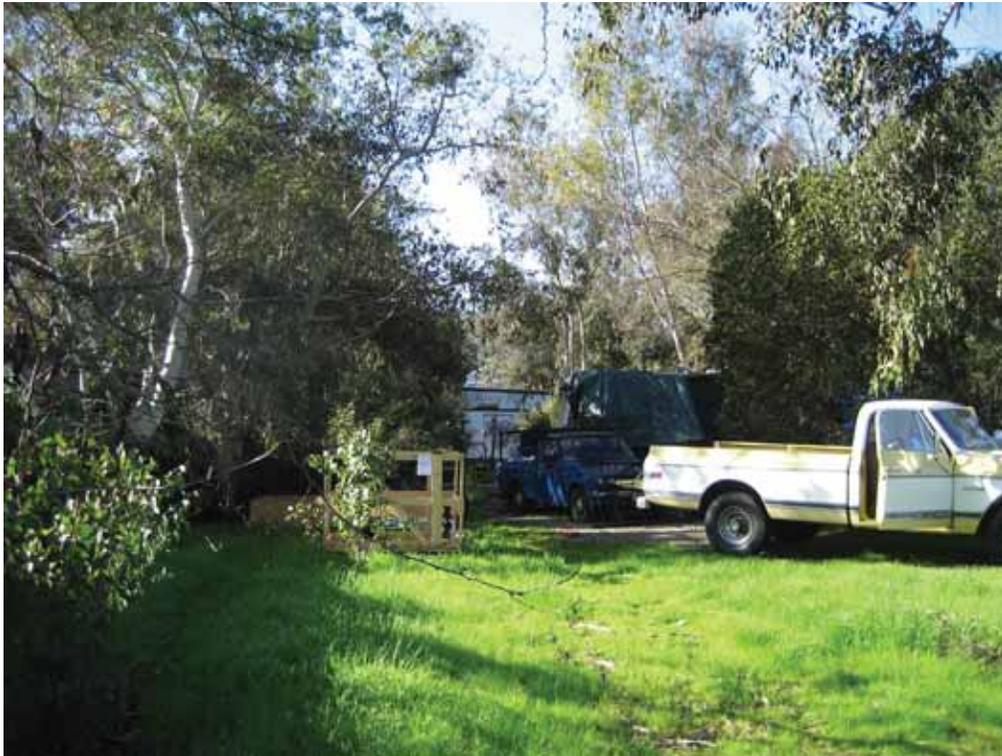
**Photo 9:** View of the southwestern portion of the subject site.

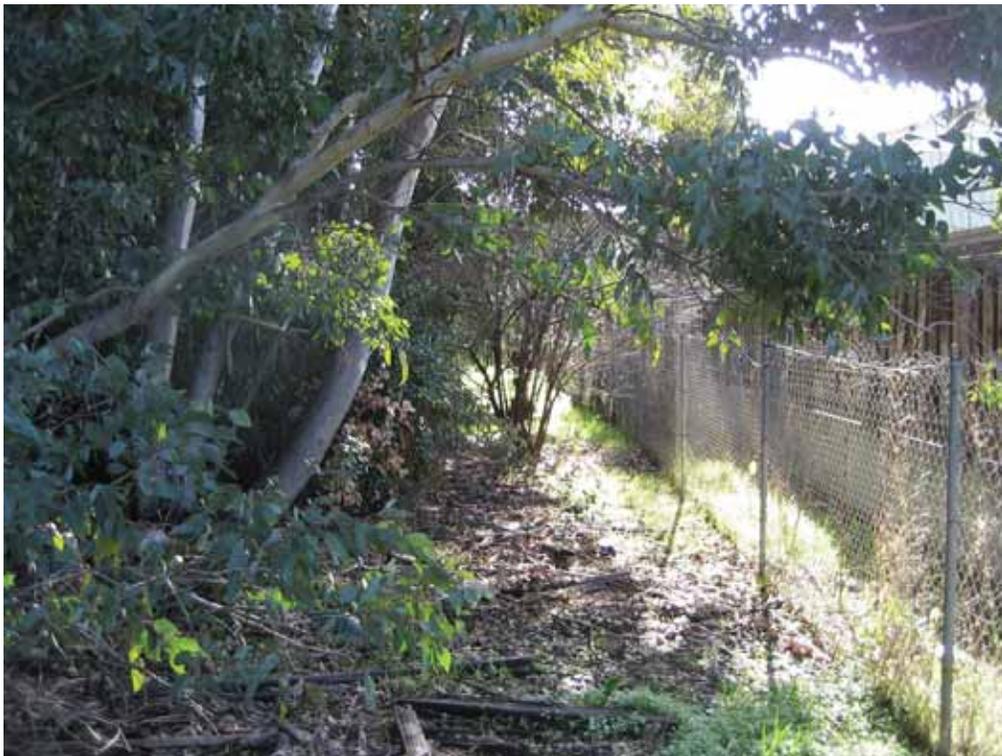
**Photo 10:** View of the far western portion of the subject site.

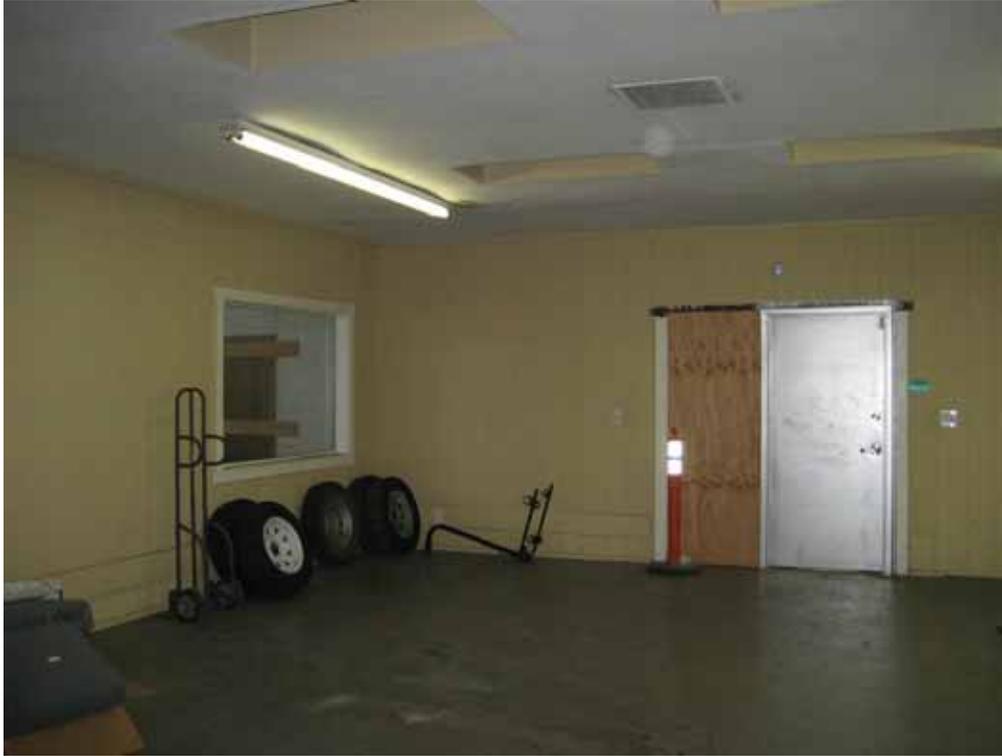
- Other than small quantities of common cleaning materials (three containers of one gallon or less) and lubricants (three one-quart containers) observed in the southeastern portion of the storage building, no hazardous materials or hazardous waste were observed on the subject site. However, interior access to a tractor trailer, two smaller trailers, and two RVs located on the subject site was not obtainable at the time of the site reconnaissance. Mr. Scoffone, the owner of the subject site for the past 15 years, stated that no chemicals or hazardous materials are contained within any of the above-referenced trailers/RVs or within any of the other vehicles located on the subject site other than fuel and engine fluids contained within fuel tanks and drive trains.

**Photo 11:** Interior view of the storage building (southern-most building) located in the southeastern portion of the subject site.

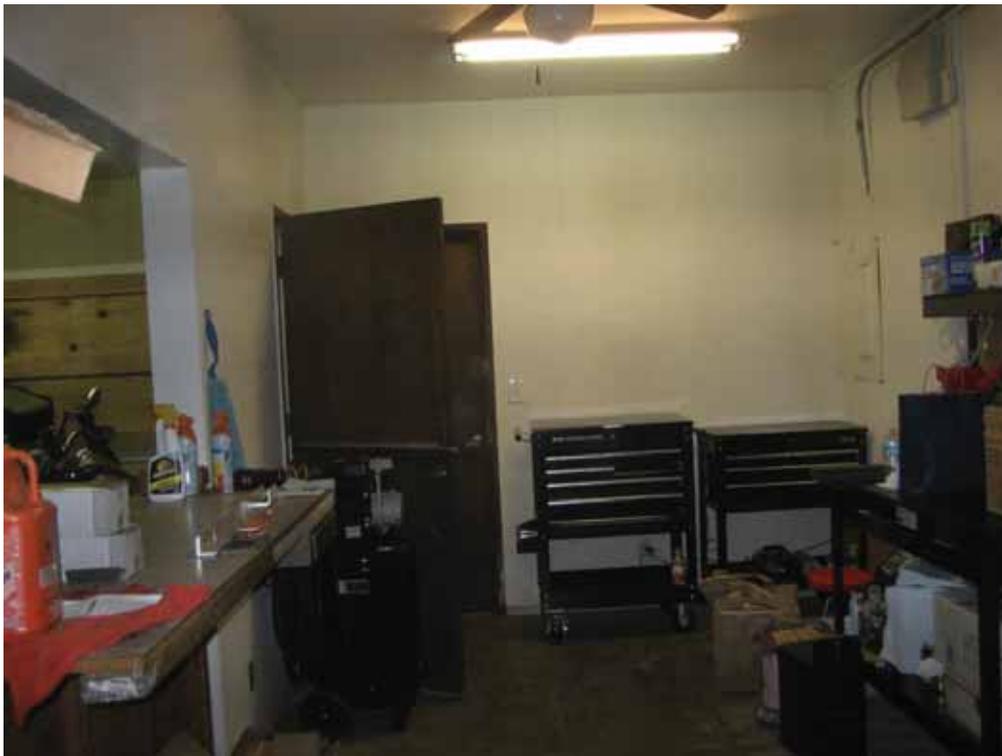
**Photo 12:** Interior view of the former office portion of the storage building (southern-most building) located in the southeastern portion of the subject site.

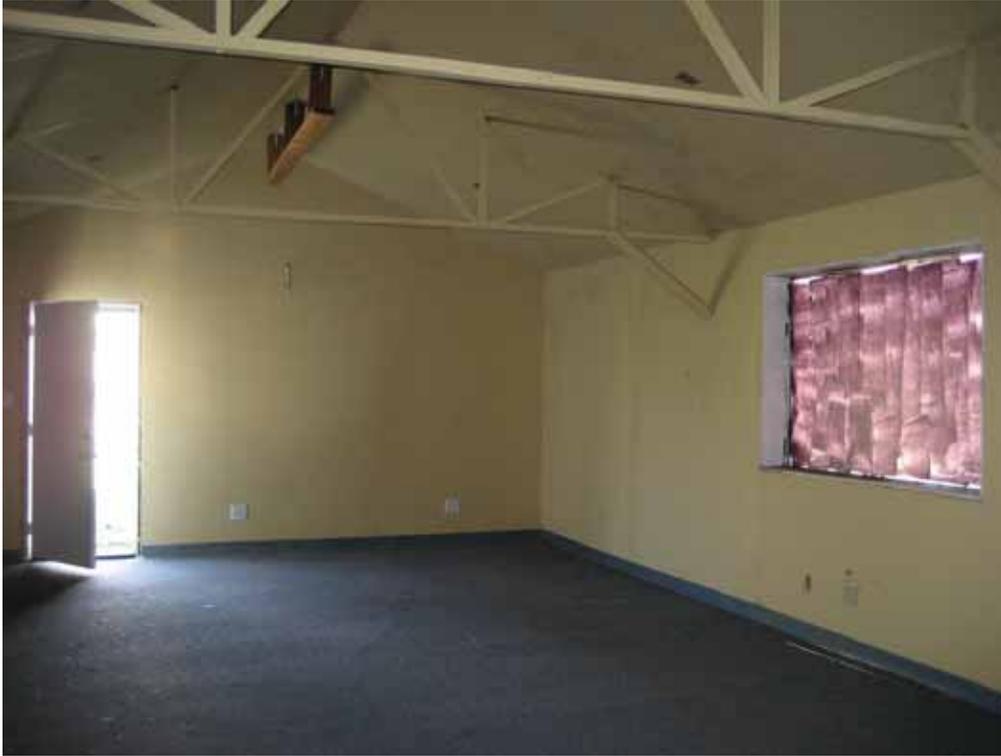
**Photo 13:** Interior view of the former greenhouse building (northern-most building) located in the northeastern portion of the subject site.

- At the time of Krazan's January 10, 2019 site reconnaissance, the on-site structures were not occupied by a business entity nor being utilized for any commercial purpose. The southern-most building was observed to include a former product display/sales area, an office area, a restroom, and a former outdoor display area which had been enclosed and fitted with a roll-up door. The southern-most building was being utilized for personal storage by Mr. Scoffone and was observed to contain two sedans, four motorcycles, and dry goods; however, much of this structure was empty (See Photographs No. 11 and No. 12). Mr. Scoffone stated that the subject site was occupied by a plant nursery historically, and the southern-most building had been utilized for the display of indoor plants and for sales/office purposes. Mr. Scoffone stated that the western portion of this building was historically a concrete slab utilized for display/storage of outside plants. Mr. Scoffone stated that he constructed the enclosure with the roll-up door after his purchase of the property. The northern-most building was observed to be largely empty (See Photograph No. 13), although a piano was being stored in the southern portion of this building. Mr. Scoffone stated that this building had been constructed as a greenhouse originally, and this structure was observed to be consistent with greenhouse use.

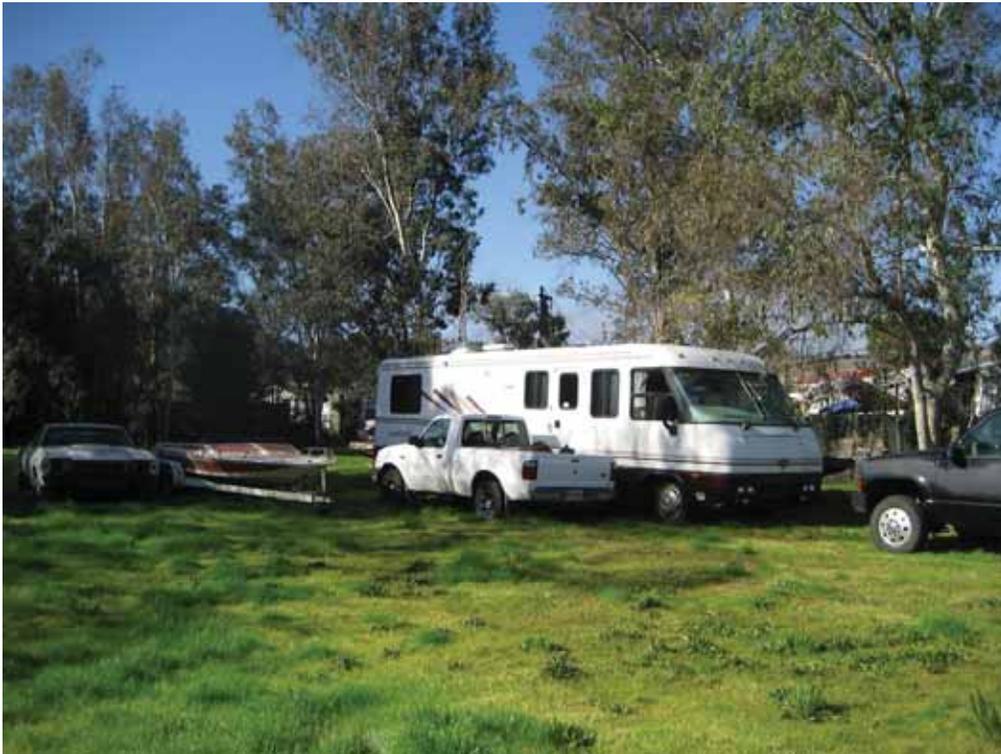
**Photo 14:** View of stored vehicles located in the northwestern portion of the subject site.

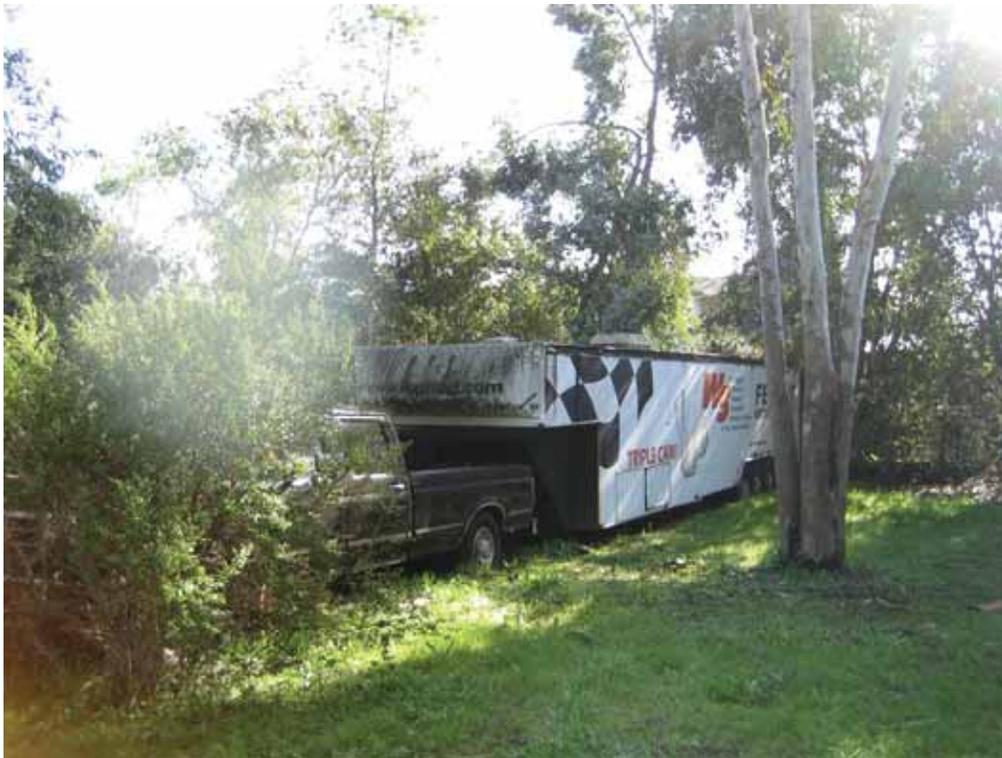
**Photo 15:** View of truck and trailer located in the southwestern portion of the subject site.

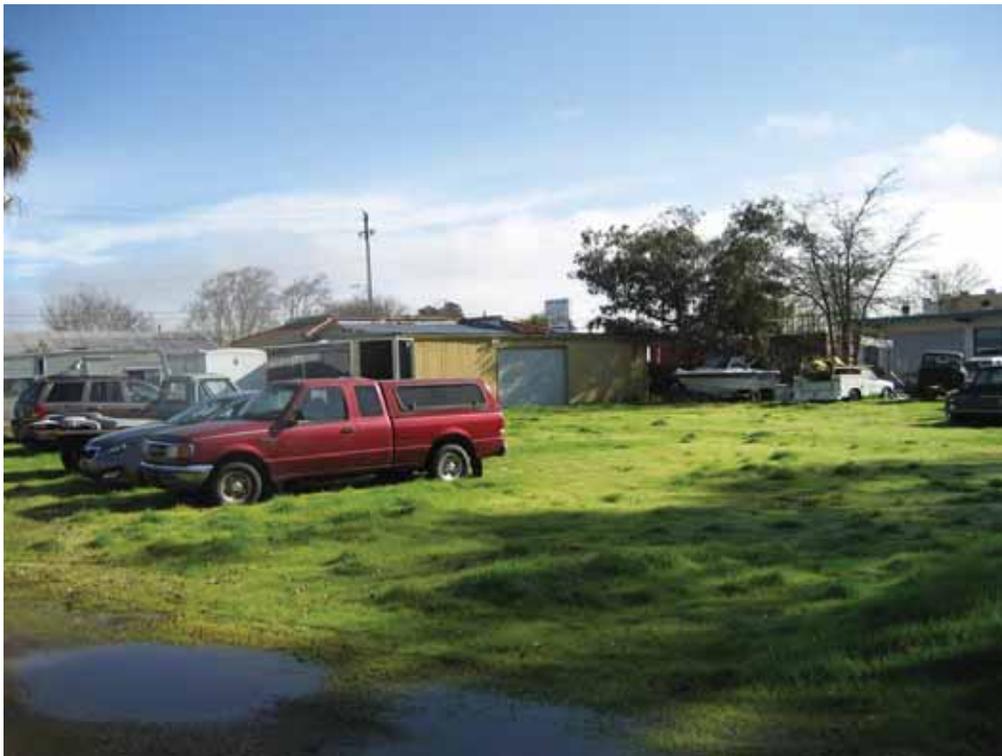
**Photo 16:** View of stored vehicles located in the northeastern portion of the subject site.

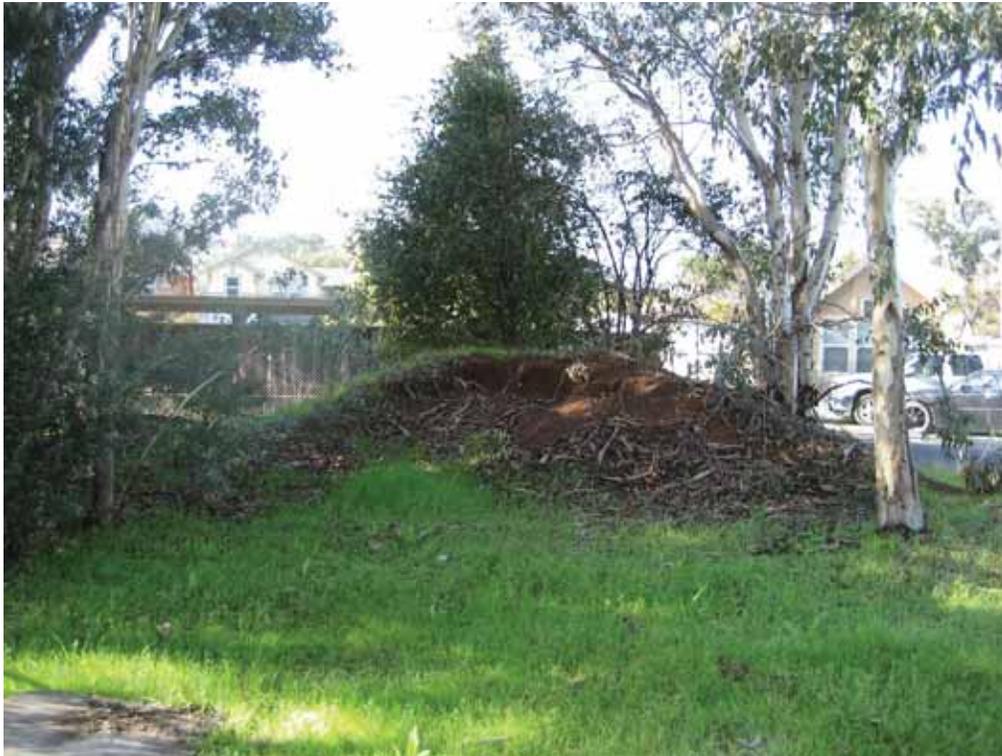
- A mound of soil partially covered with vegetation was observed in the northwestern corner of the subject site (See Photograph No. 17). No odors, discolored soil, or other obvious evidence of the presence of hazardous materials/waste was noted in association with the soil mound, although only the surface material of the mounded soil was observable. Additionally, a mound of at least loosely consolidated asphaltic material was observed in the northwestern corner of the subject site adjacent to the soil mound (See Photograph No. 18).

**Photo 17:** View of soil mound located in the northwestern corner of the subject site.

*For a higher level of due diligence, Krazan recommends that soil samples be collected from the on-site soil mound and analyzed to assess the presence or absence of potential significant concentrations of constituents of concern to determine whether or not the soil can be spread on site at the time of redevelopment or for disposal purposes if found to be inappropriate for use in connection with the proposed residential redevelopment.*

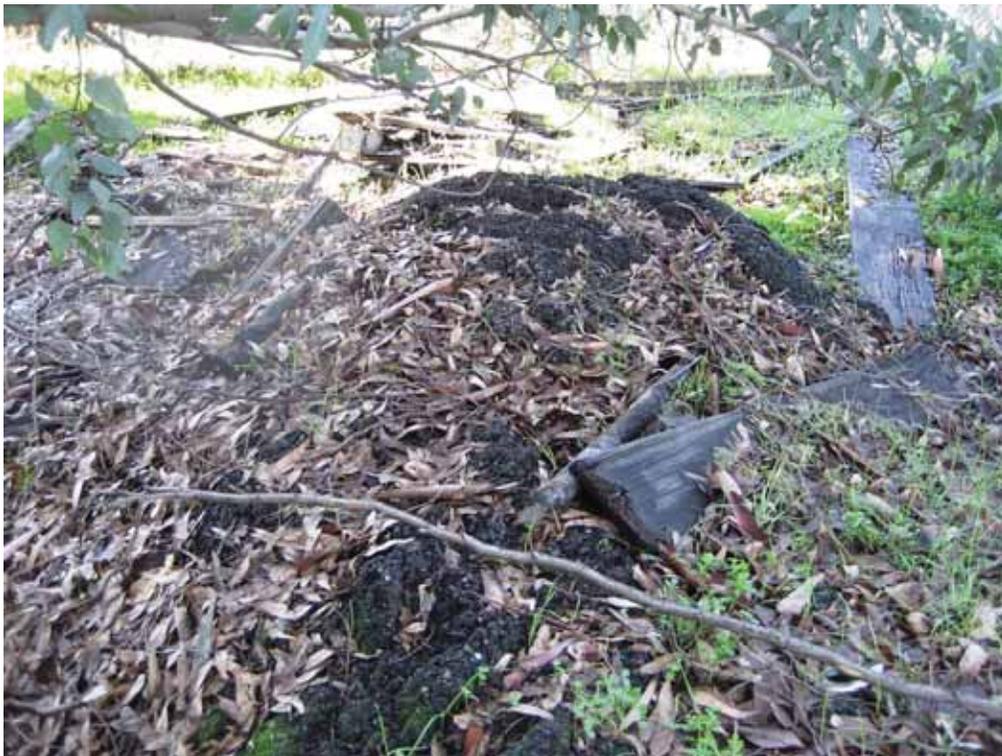
**Photo 18:** View of mounded asphalt located in the northwestern corner of the subject site.

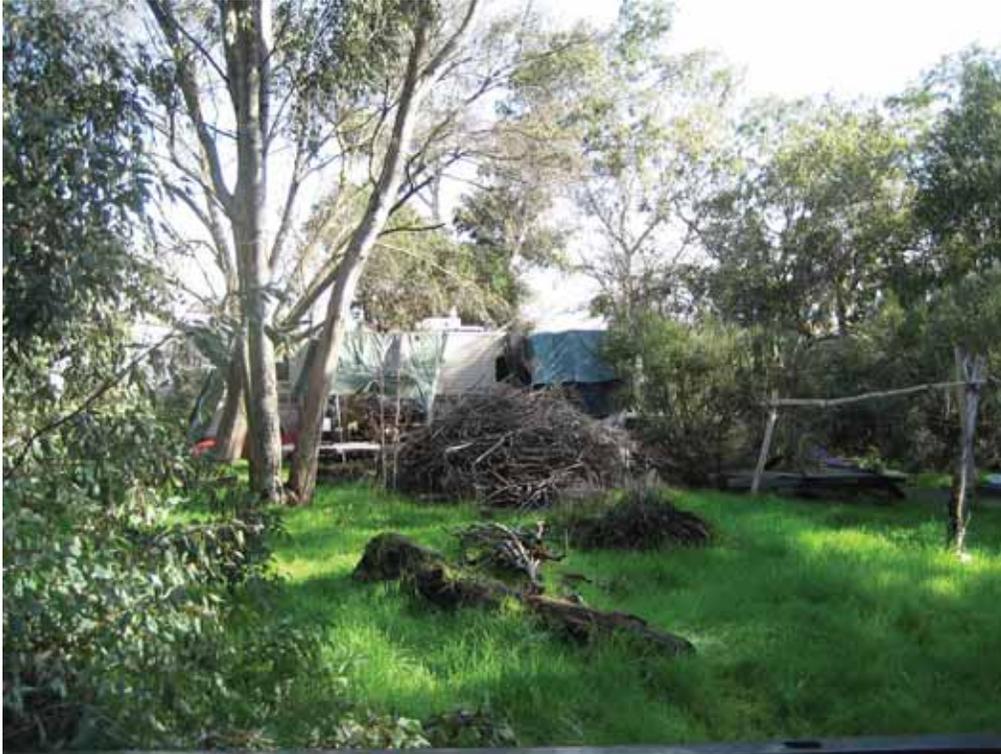
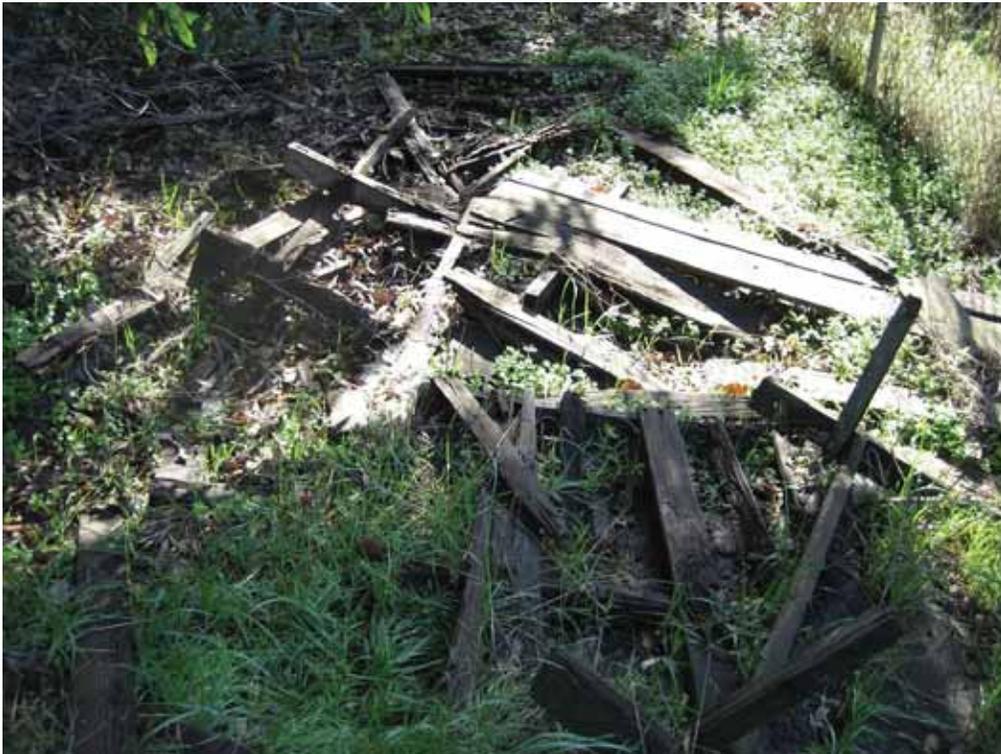
- Piles of vegetative debris were observed in the southwestern portion of the subject site and wooden debris and several broken clay pots were observed in the central-western portion of the subject site (See Photographs No. 19 and No. 20). No hazardous materials or hazardous waste were observed in association with the vegetative debris or wooden/clay debris.

**Photo 19:** View of vegetative debris located in the southwestern corner of the subject site.

**Photo 20:** View of wooden debris located in the far western portion of the subject site near the property boundary.

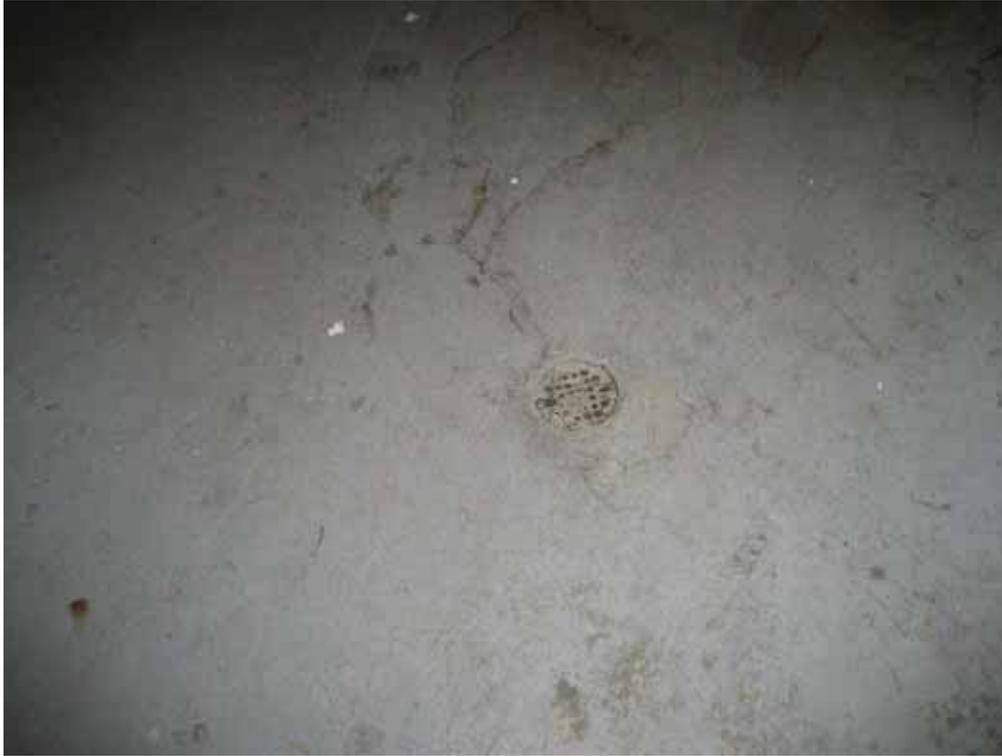
- A floor drain was observed in the central portion of the storage building located in the southeastern portion of the subject site (See Photograph No. 21). According to Mr. Scoffone, the floor drain is connected to the municipal sewer system. No odors, surface staining, or other evidence of the disposal of hazardous materials or hazardous waste was observed within or adjacent to the on-site floor drain.

**Photo 21:** View of the floor drain located in the eastern portion of the southern-most storage building.

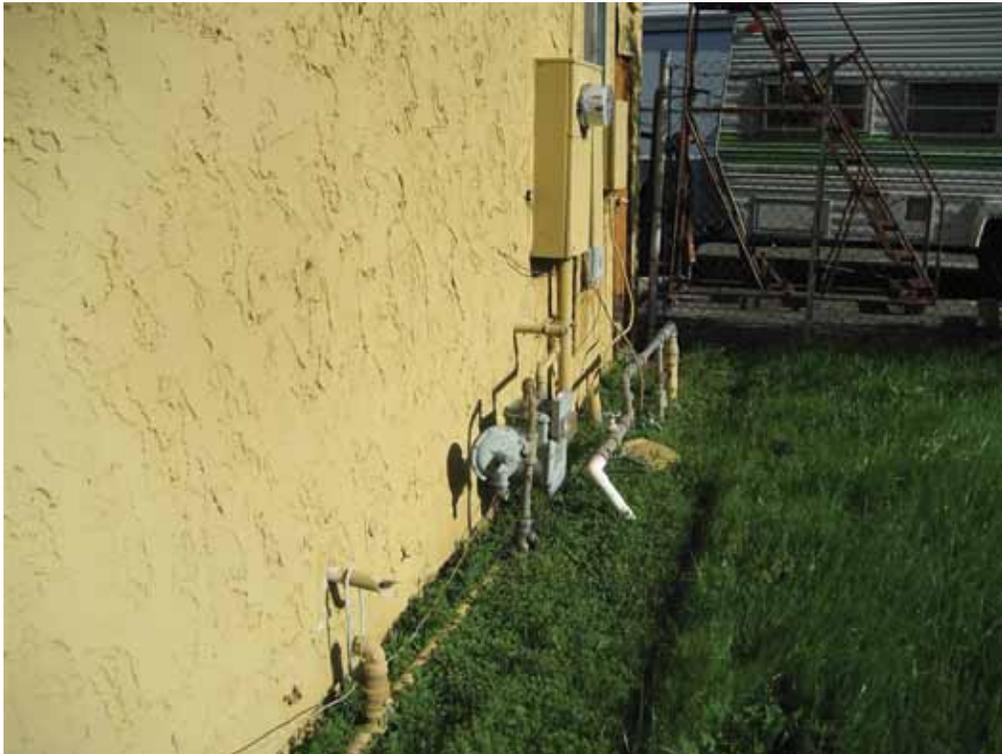
- A natural gas meter/valve and main electrical service were observed in association with the on-site building (See Photograph No. 22).
- The remainder of the subject site not occupied by the previously referenced structures/features was observed to be occupied by paved and unpaved driveways/parking areas, paved walkways, and landscaped grounds. No evidence of hazardous materials storage or hazardous waste was observed within these portions of the subject site except as previously noted. Several areas of minor engine-drip related surface staining were observed within the paved parking area located in the eastern portion of the subject site and this pavement staining is considered to be *de minimis*.

**Photo 22:** View of the natural gas valve/meter located in the southeastern portion of the subject site.
