APPENDIX E

**BIOTIC EVALUATION
COCHRANE/PEET ROAD ORCHARD PROPERTY
CITY OF MORGAN HILL, SANTA CLARA COUNTY, CALIFORNIA**

Project No. 1546-02

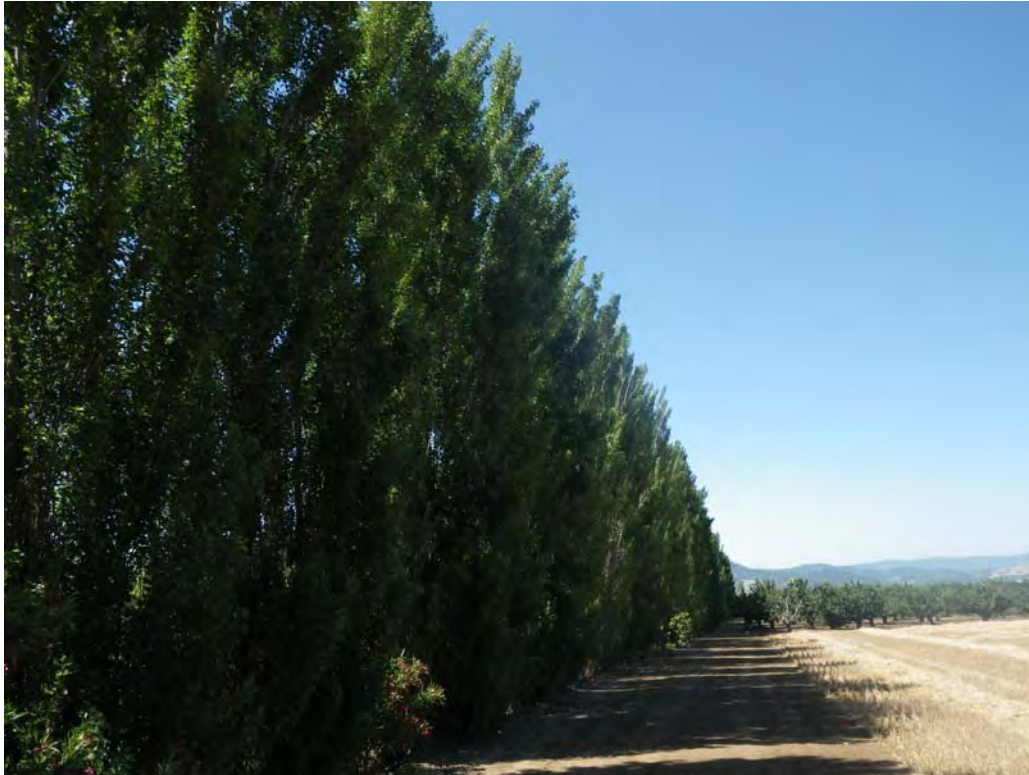
Photograph 1 (above). Rows of Lombardy poplar trees line Half Road and Coyote Road within the project area. These nonnative trees will be retained and protected. **Photograph 2 (below).** Coast live oaks were identified along the northern portion of Coyote Road during the tree survey.

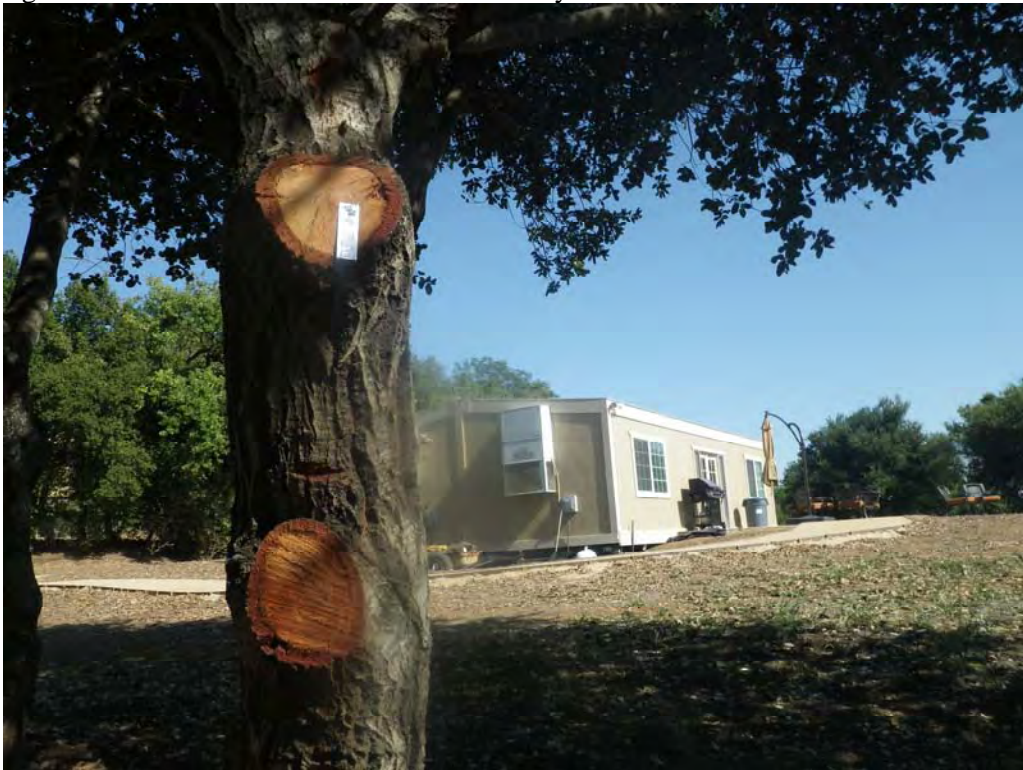
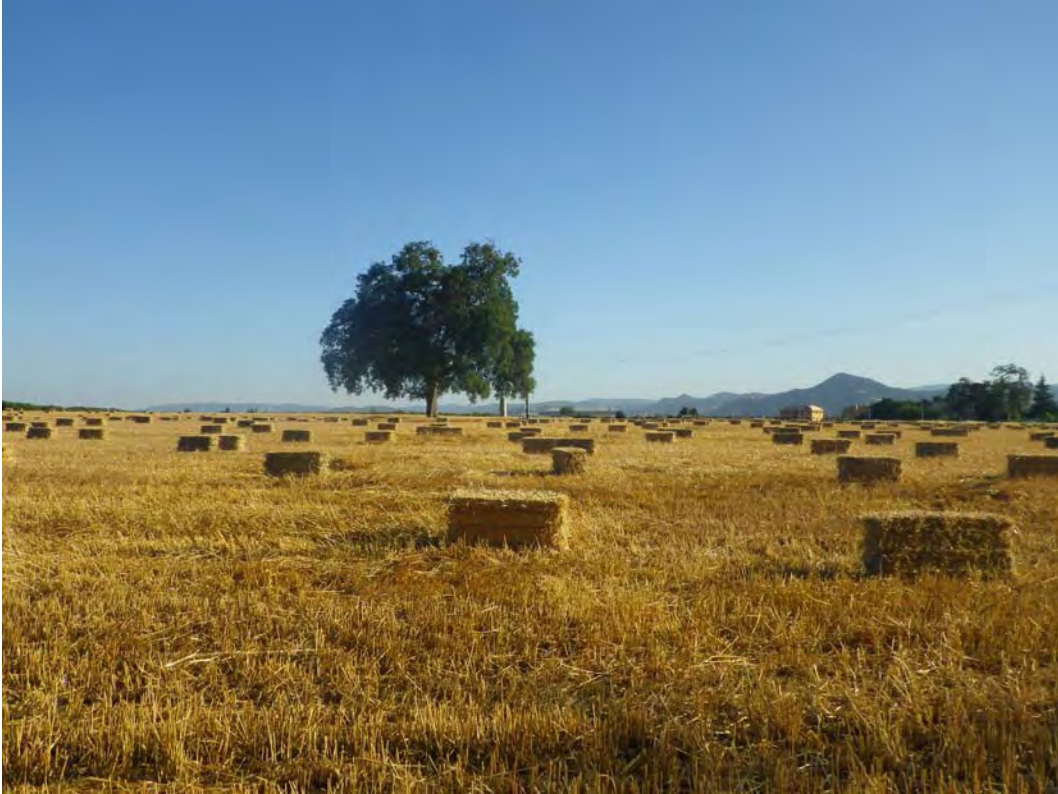
Photograph #3 (above). LOA' recent tree tag was nailed into all ordinance trees (right). The previous tree tags (left) were found on some of the trees and were either reused or folded in place.
Photograph #4. (below). A few of the oak trees appeared to have been recently pruned near this building located near the site's northeastern boundary.

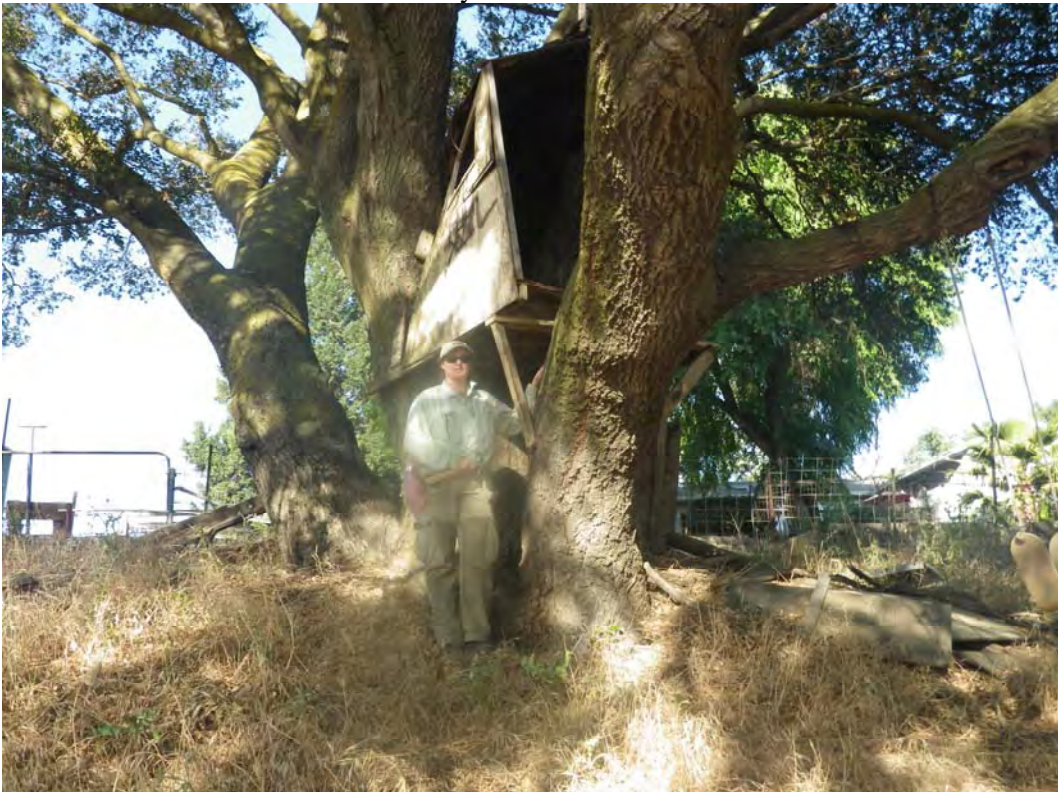
Photograph #5 (above). One of the large coast live oaks that will be preserved and built around.
Photograph #6 (below). A former treehouse was found within this extremely decadent coast live oak located near the sites northern boundary.
