# Geologic Impact Analysis

Lillian Commons/Morgan Hill Medical Campus

Morgan Hill, California

October 16, 2019 | Project No. 403487001

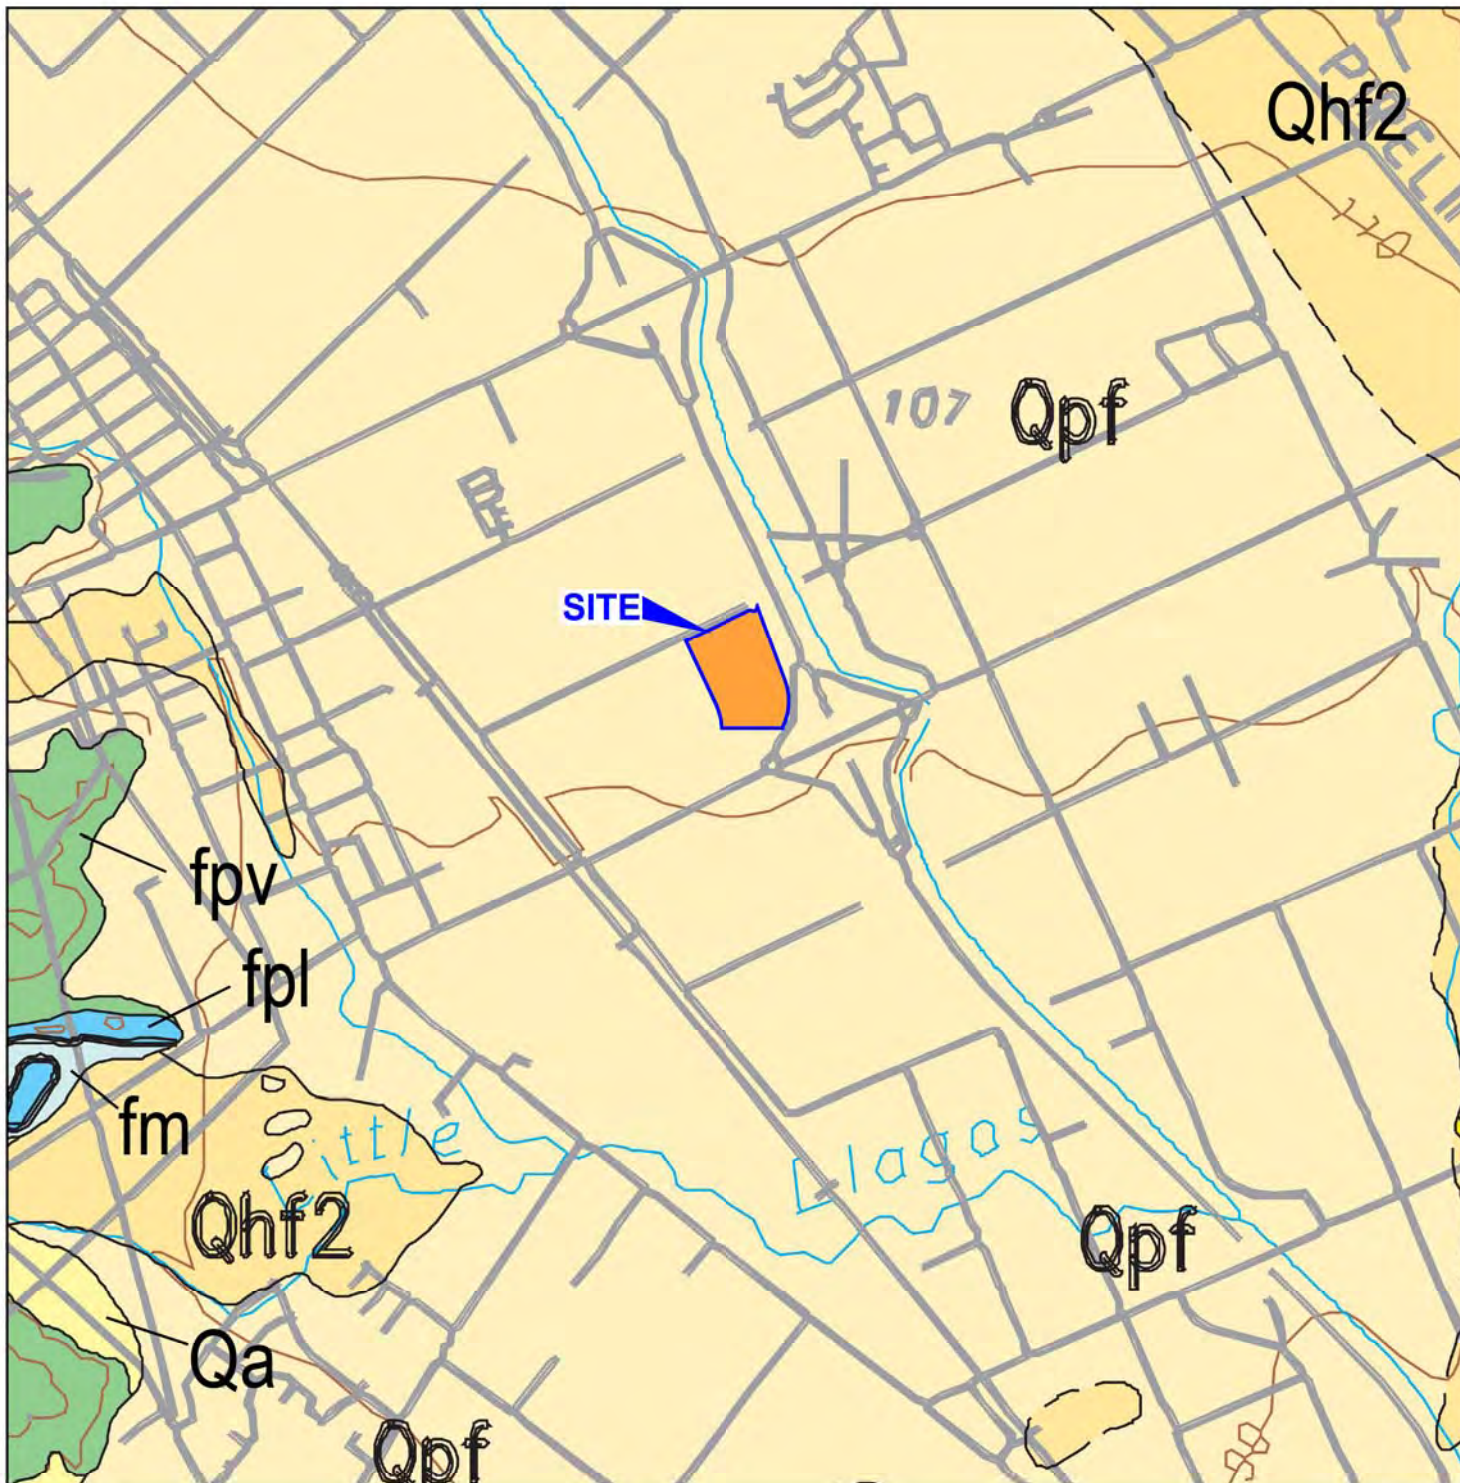
| <b>Qa</b> | ALLUVIUM, UNDIVIDED (QUATERNARY) | <b>Qpf</b> | ALLUVIAL FAN DEPOSITS (PLEISTOCENE) | <b>fpl</b> | LIMESTONE (CRETACEOUS) |

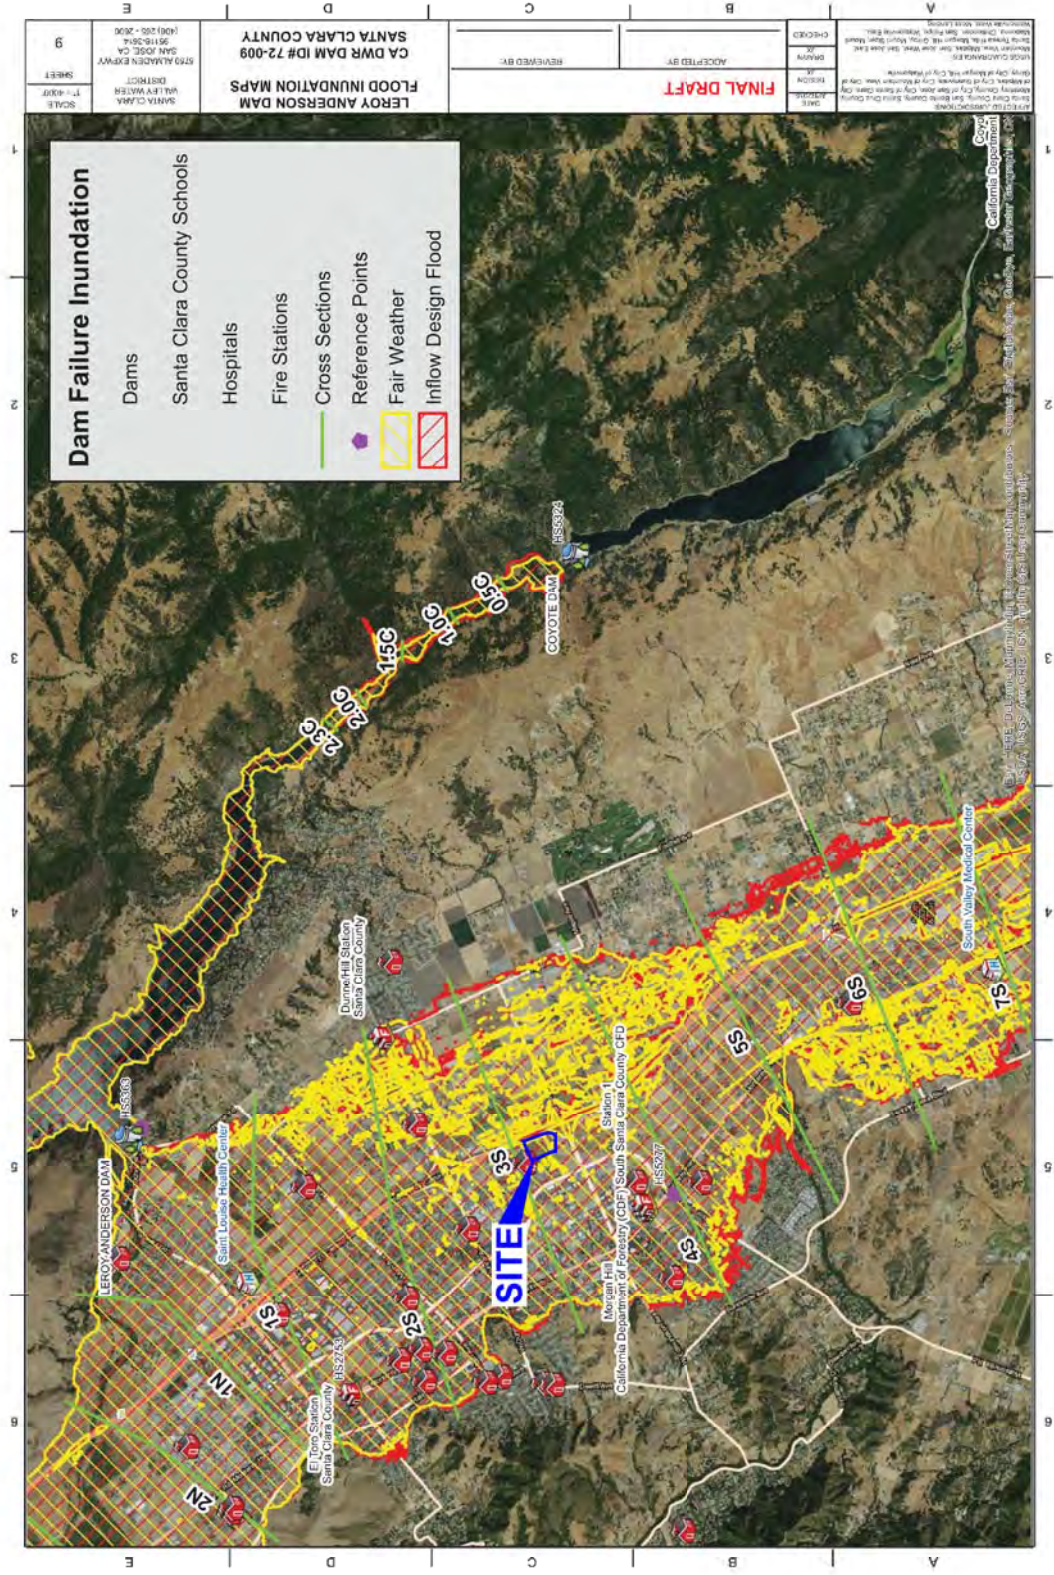
FIGURE 8

**DAM FAILURE INUNDATION**  
LILLIAN COMMONS/MORGAN HILL MEDICAL CAMPUS  
JUAN HERNANDEZ DRIVE  
MORGAN HILL, CALIFORNIA  
403487001 | 10/19

Flooding can also occur when dams of nearby reservoirs fail and inundate the surrounding downstream areas. The site is located within the inundation area for the Leroy Anderson Dam, which is located approximately 3 miles to the northeast. A portion of the inundation map prepared by the Santa Clara Valley Water District (2016) is provided as Figure 8. Flooding due to dam failure should be considered during design phases of the proposed development.

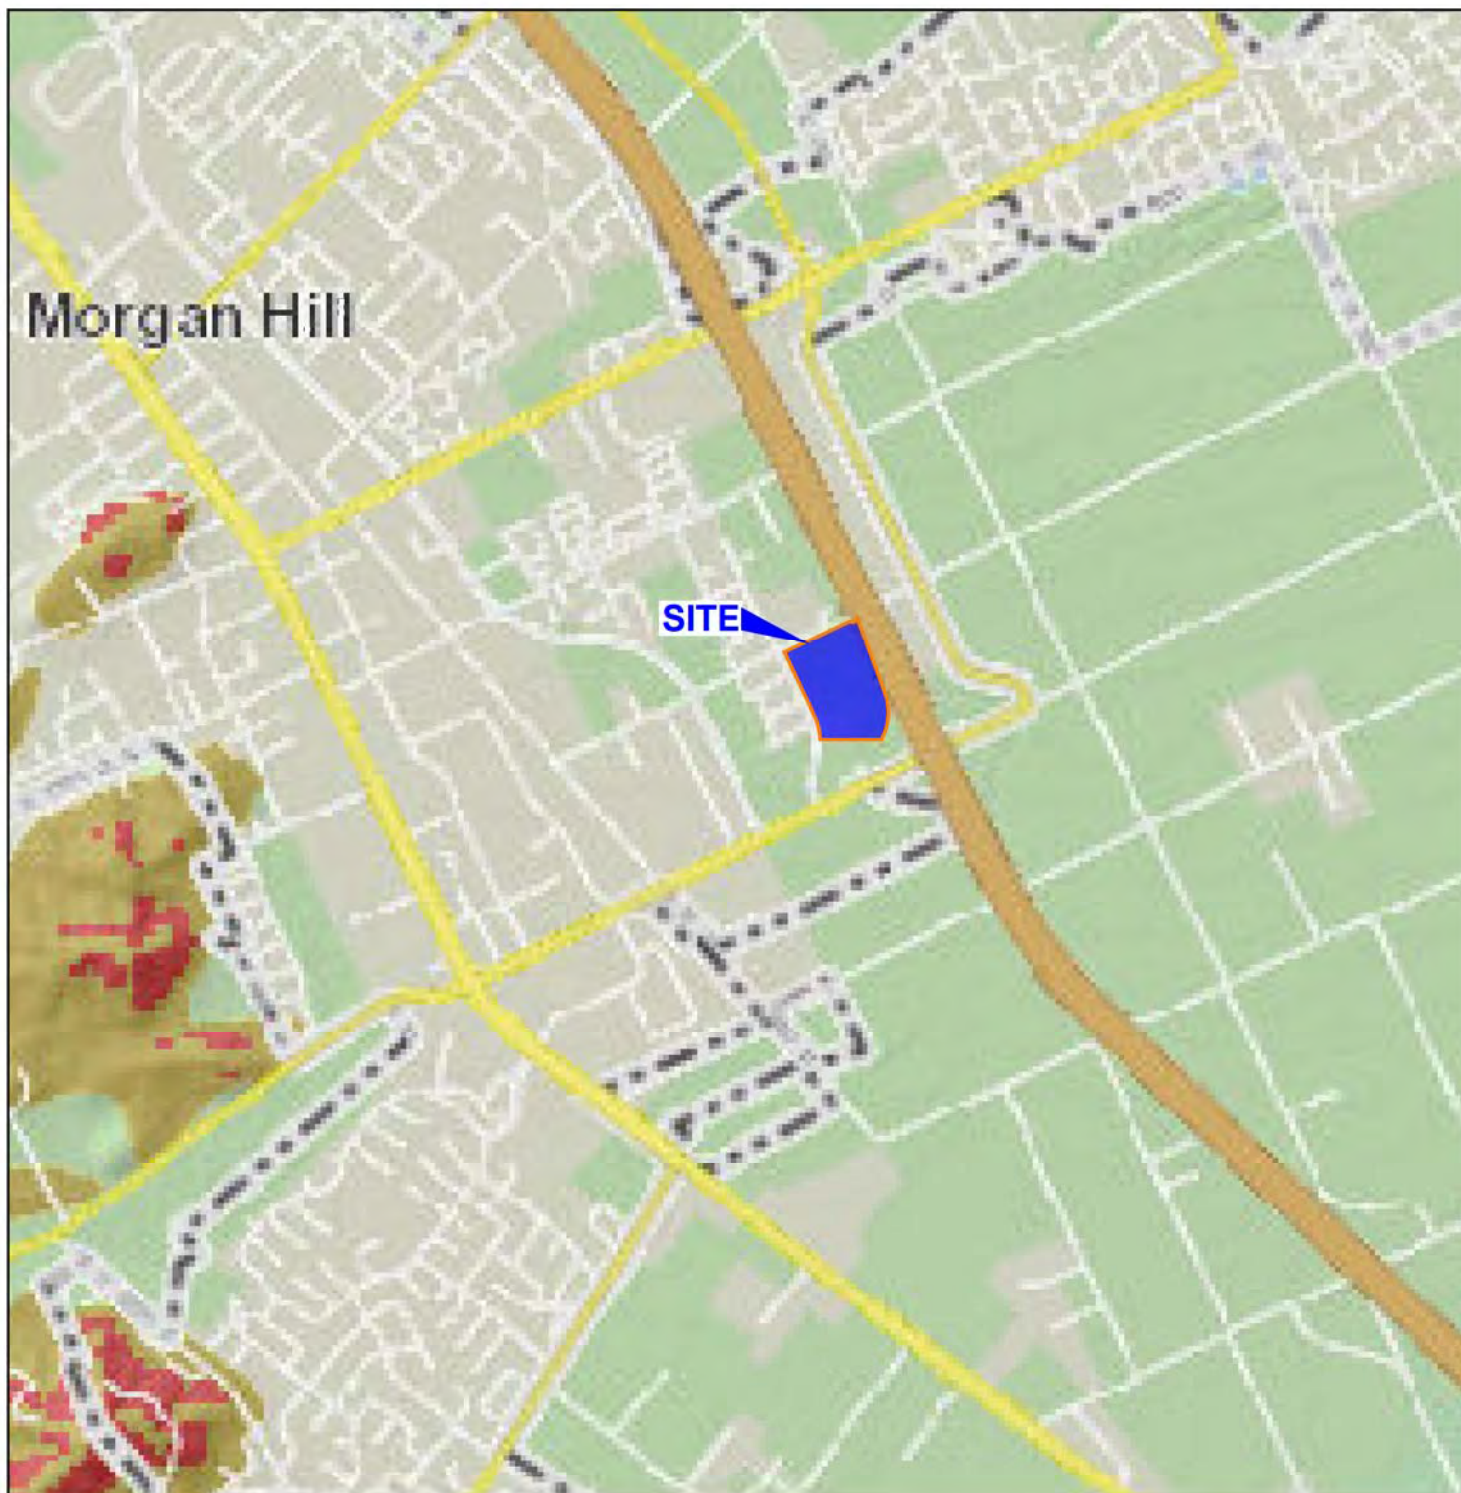
| | POTENTIAL DEBRIS FLOW SOURCE | | MANY LANDSLIDES | | VERY FEW LANDSLIDES |

The study area is located within an area with a low susceptibility to liquefaction and not within a seismic hazard zone for earthquake-induced landslides (Figures 6 and 9). The potential for seismic-related ground failure exposing people or structures to substantial adverse effects is likely to be low.
